Manhole Inspection Summary

Manhole # S15EE1004MH

Insp Date: **3/6/07 10:35 AM**

Location Address: **2515 KEYWORTH AVE**

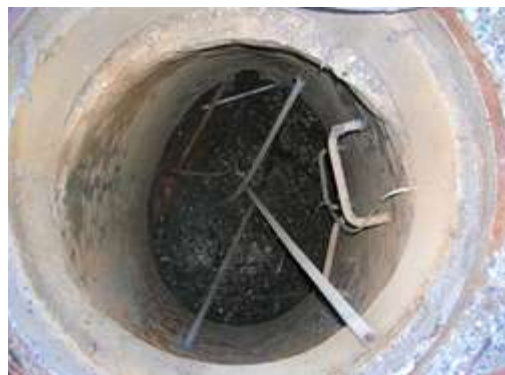
Top View

Channel debris.

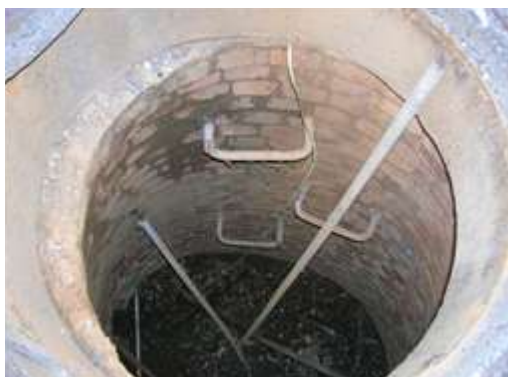
Defect

Frame leaks. Frame offset. Adjustment deterioration and infiltration. Corbel and Barrel infiltration - other side.

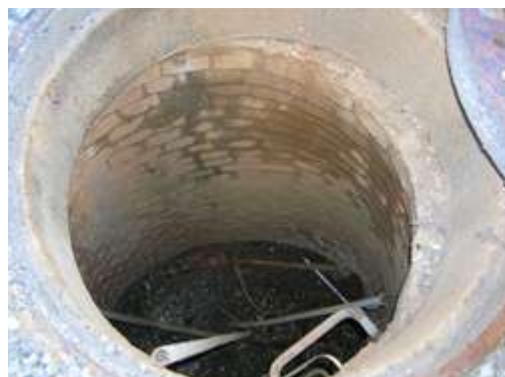
Defect

Frame leaks. Frame offset. Adjustment deterioration and infiltration. Corbel and Barrel infiltration.

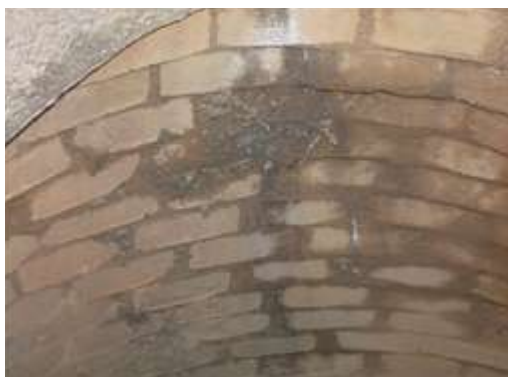
Defect

Corbel root intrusion and infiltration.

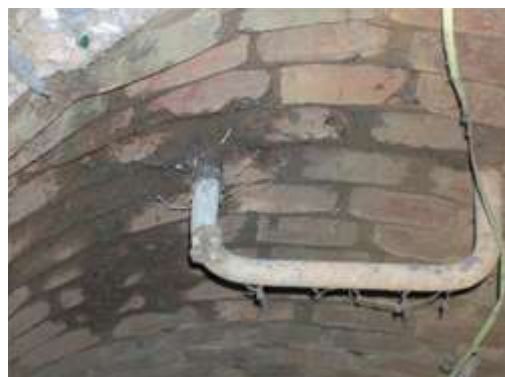
Defect

Corbel root intrusion and infiltration - other side.

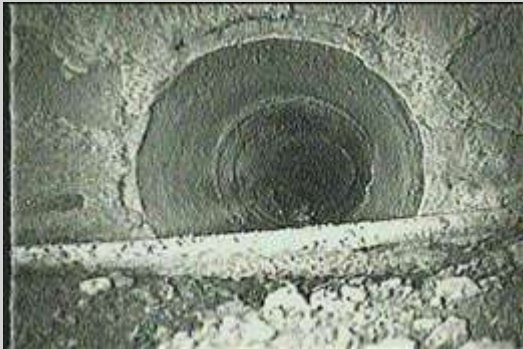
8 in. Circular Gravity Sewer
Pipe Out @ 12 O'Clock

Deposits: ☐ None ☒ **Mud** ☐ Sludge ☒ **Debris** ☐ Grease

Silt Depth: **0.5** (in.) Deposits Extent: **Light**

Infiltration: **Evidence** Pipe Seal Cond: **Cracked**
